**PRE-DEMOLITION ASBESTOS/LEAD SURVEY: LINCOLN ACRES LIBRARY, 2717
GRANGER AVENUE, NATIONAL CITY**

PRE-DEMOLITION ASBESTOS/LEAD SURVEY: LINCOLN ACRES LIBRARY, 2717 GRANGER AVENUE, NATIONAL CITY

Lincoln Acres Library

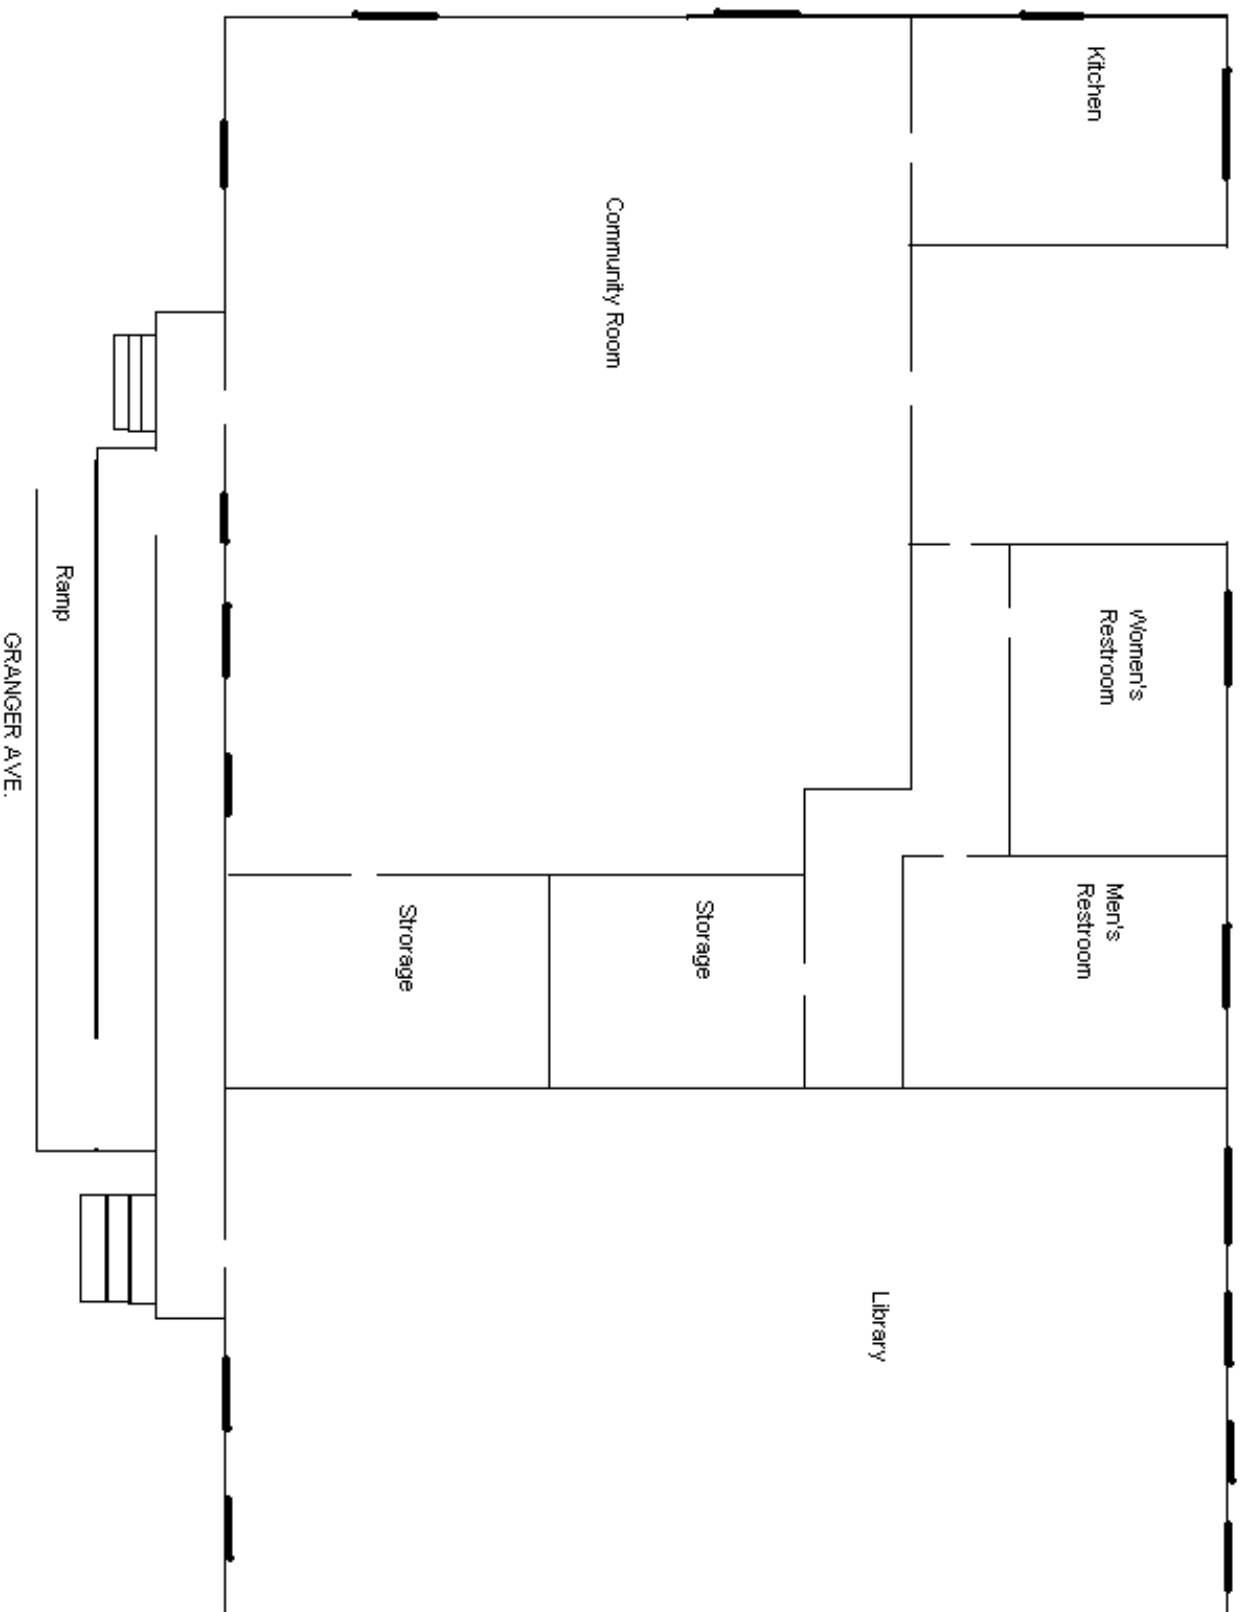
The property contains a single story structure that is divided into a Library and Community Center. A lay-out of the structure is provided as Attachment 1. The structure has wood frame construction with a stucco exterior and multi-layered composition roof shingles. There did not appear to be any blown in attic insulation. Moreover, the water pipes did not appear to be insulated. The interior walls of the building consisted of wood, fiberboard, drywall and plaster. The ceiling consisted

1. No attic insulation
2. No insulated pipes
3. FT throughout Community Room over wood
4. CR: Wood, Plaster & Drywall
5. Library: Linoleum in hallway and restrooms
6. FT in library and storage
